Property Inspection Report

123 Your Street, Pittsburgh, PA 15222

Mar 6, 2016

2016-12345

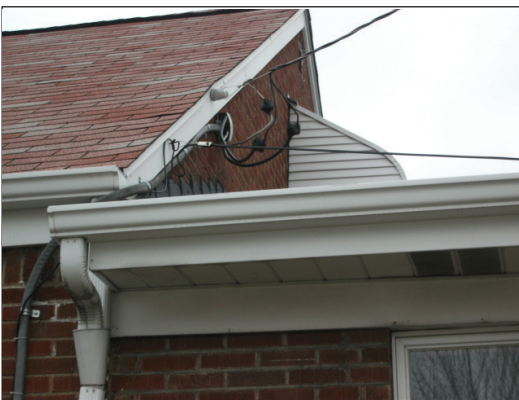
Comments Service Entrance Clearance Poor. Installation was approved by Steel City Inspections.

Poor clearance of electrical service entrance.

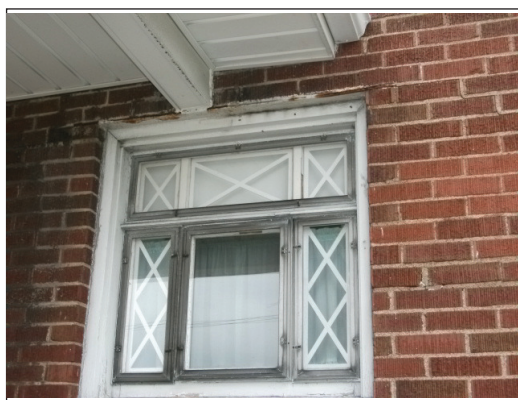
Comments The exterior siding or brick is cracking in some locations due to window lintel deterioration and metal expansion. A couple of lintels will need replaced to preserve exterior brick.

Window lintels and maintenance needed

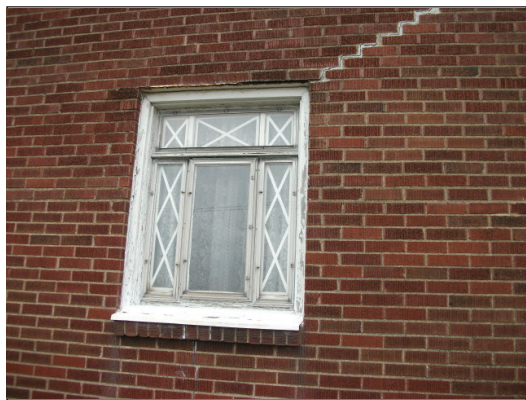
Damaged Lintel and expansion thru brick.

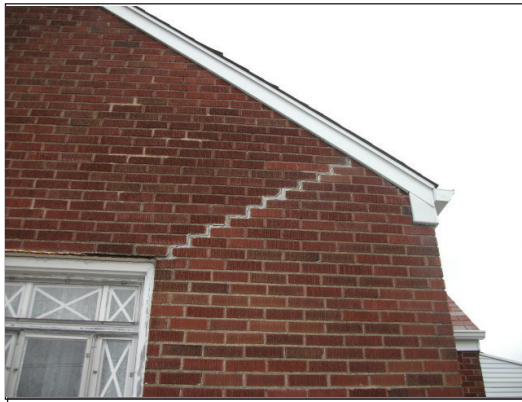
Repair attempt to brick.

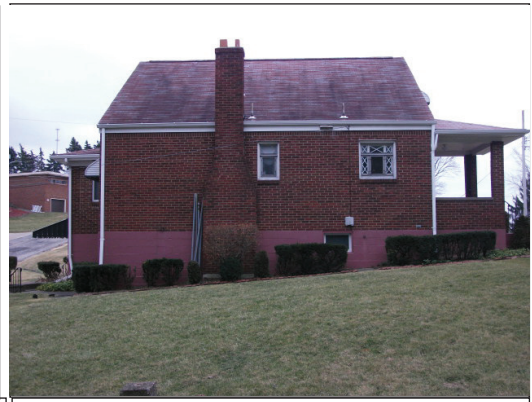
Rain Cap & Bird Screen Rec. To Chimney

Comments Recommend bird screen and rain cap be installed on top of chimney flue to preserve cap.

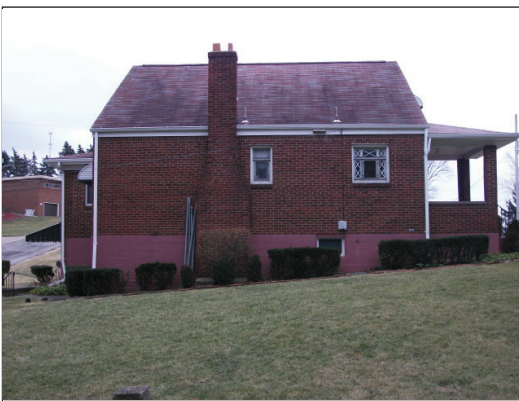
Comments The shingles on the east side of the house appear older and with a different shingle exposure. It is likely it was applied earlier than the other roof areas.

East side of subject.

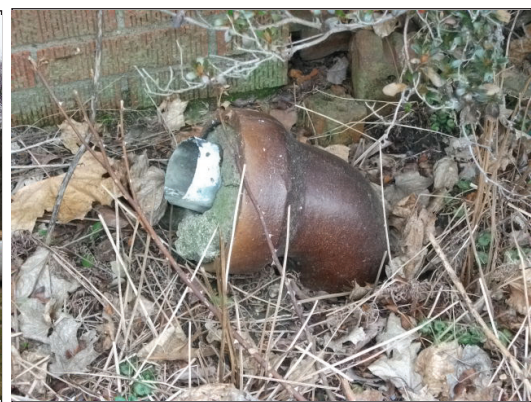
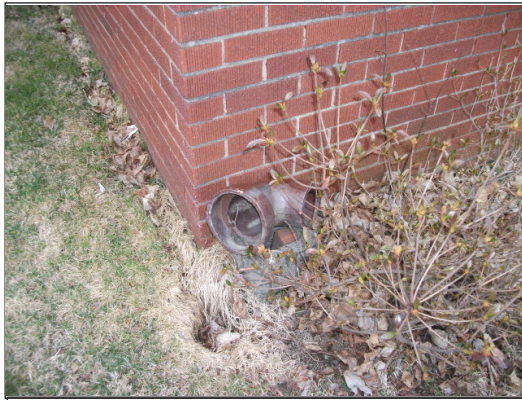
Comments The in ground leader drains are broken and not being used. Drainage is to ground discharge, the same as the house.

Garage broken loose leader

Garage Broken Loose Leader

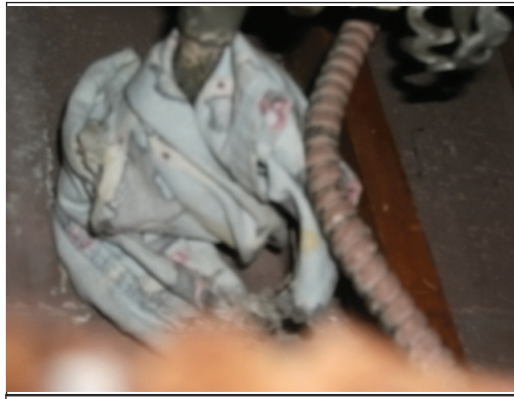
The electrical system is a 200 Amp GE Main Panel with the same over current protection. The branch wiring is Romex cable and BX cable. The vast majority of outlets in the home are non grounded indicating the age of the general interior wiring. On circuits where BX cable is being used grounded outlets may be used. There are 12 single pull circuits and 1 two pull circuit for the range circuit. The safety hazard to be evaluated is for bonding and continuity of the branch circuits and outlets. It is also recommended that ground fault circuit interrupters be installed in all outside outlets and outlets within 6 feet of a water source. This includes the garage. General upgrades are recommended.

BX Cable in Ceiling Area

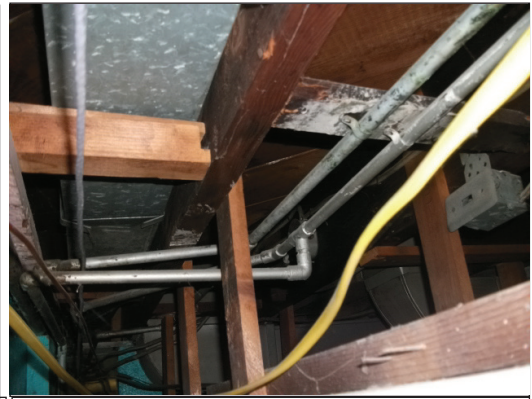
Hidden wiring electrical in ceiling.

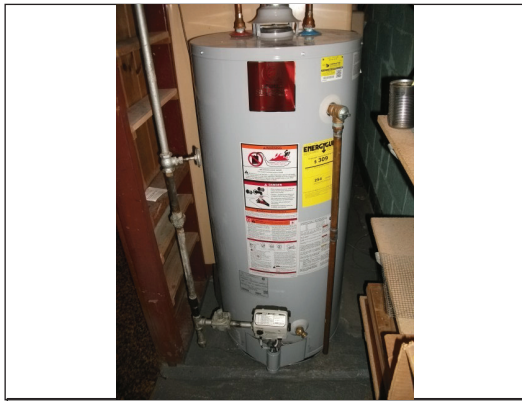
Comments Improved combustion air in to hot water tank area recommended. The draft of the flue was good when checked.

Hot Water Tank

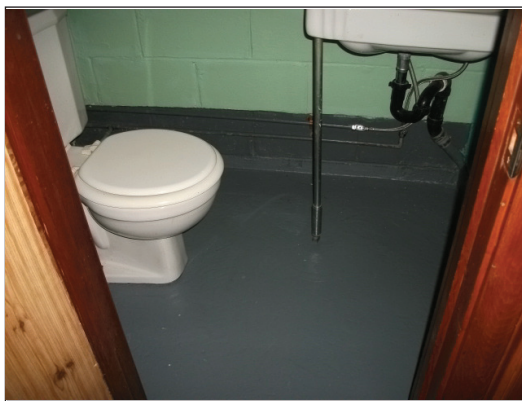
The drain on the sink in the basement bathroom area was not properly installed. While functioning properly and not likely to be a problem it is proper you be made aware of the condition. The supply lines for water in the house may contact a little of galvanized piping since rusty water released when valve open. It may also be the sacrificial rod in the hot water tank which is designed to do this if sitting for a long period of time.

Poor Installation Sink Drain

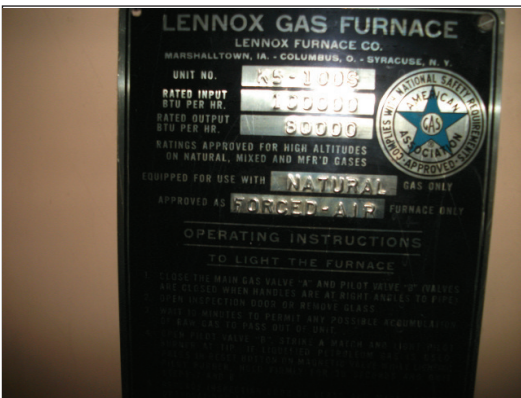
The heating system is older and has an efficiency rating of between 50-60 percent. The replacement of the system should be considered. The current system is operational and will likely continue as it was a well designed system for its time. The ductwork output at the registers needs balance which is typical of most systems inspected in older homes.

Furnace Information Plate
