Property Inspection Report

123 Your Street, Pittsburgh, PA 15222

Mar 6, 2016

2016-12345

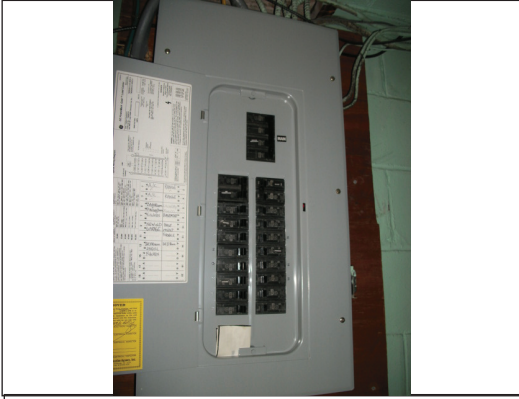
Main Service Panel & Approval

The electrical system is a 200 Amp GE Main Panel with the same over current protection. The branch wiring is Romex cable and BX cable. The vast majority of outlets in the home are non grounded indicating the age of the general interior wiring. On circuits where BX cable is being used grounded outlets may be used. There are 12 single pull circuits and 1 two pull circuit for the range circuit. The safety hazard to be evaluated is for bonding and continuity of the branch circuits and outlets. It is also recommended that ground fault circuit interrupters be installed in all outside outlets and outlets within 6 feet of a water source. This includes the garage. General upgrades are recommended.

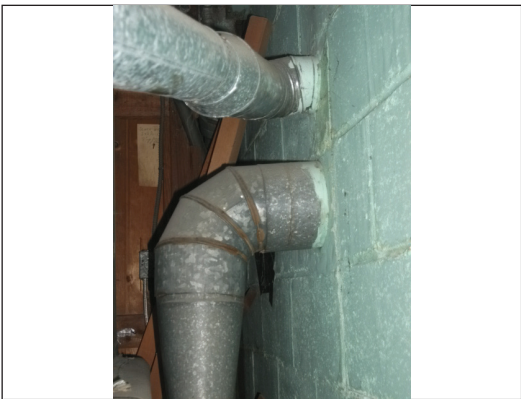
Flue for Furnace and HWT

The heating system is older and has an efficiency rating of between 50-60 percent. The replacement of the system should be considered. The current system is operational and will likely continue as it was a well designed system for its time. The ductwork output at the registers needs balance which is typical of most systems inspected in older homes.

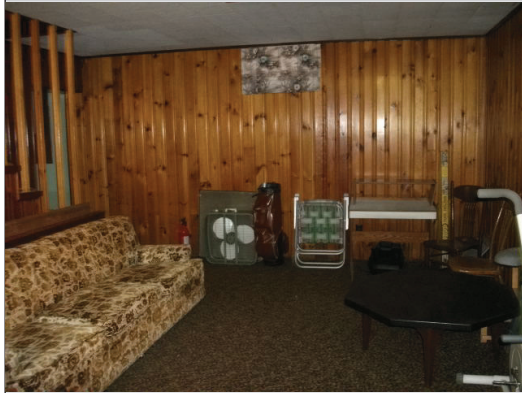
Walls & Ceiling Satisfactory Marginal Poor Typical cracks Damage
Moisture stains Yes No **Where:** Ceilings in Basement - Not Believed Active
Floor Satisfactory Marginal Poor Squeaks Slopes Tripping hazard
Electrical **Operable:** Yes No **Switches:** Yes No Operable **Receptacles:** Yes No Operable
Open ground/Reverse polarity: Yes No Safety Hazard Cover plates missing **Holes:** N/A Doors Walls Ceilings
Heating source present Yes No Not visible **Egress restricted** N/A Yes No
Doors Satisfactory Marginal Poor Cracked glass Evidence of leaking insulated glass Broken/Missing hardware
Windows Satisfactory Marginal Poor Cracked glass Evidence of leaking insulated glass Broken/Missing hardware
Ceiling fan N/A Satisfactory Marginal Poor Recommend repair/replace
